TSSA Update

Notice Regarding Underground Fuel Supply Lines - TSSA October 16, 2008

Feature Project

How to read a multiVIEW Locate Form

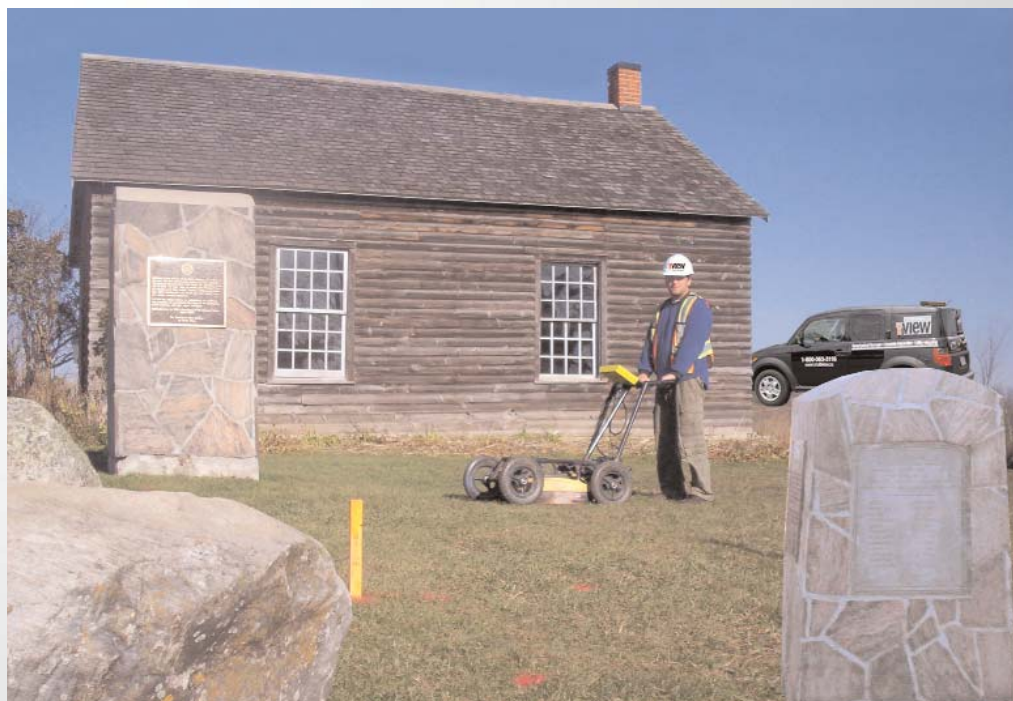
multiVIEW was retained to profile the subsurface lands surrounding the church to map anomalous conditions which may infer historic interments. Radar data were acquired over the entire site. Several unusual conditions were noted and reported back to the History Association for further review.
